TROUBLE IN PARADISE

A deep-sea vehicle helps a contractor stop effluent leaking from a treatment plant's outfall into the Caribbean Sea

PROJECT:

Repair pipe joints leaking effluent 400 feet below the Caribbean Sea

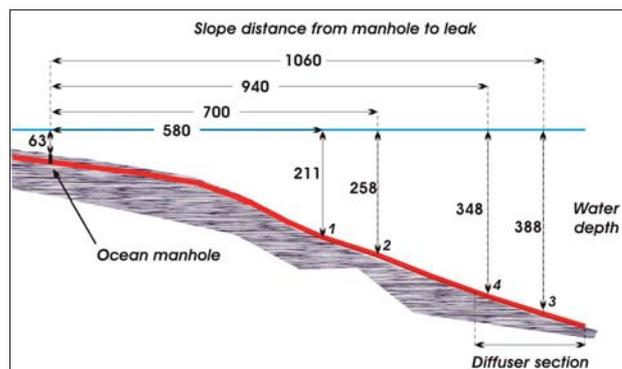
The concrete and weight-coated, spun-concrete-lined steel pipe lies in a backfilled trench. Running down a 20-degree slope near the offshore end, it breaks through the ocean floor and rests on specially designed cradles. Concrete mats provide additional ballast. Leaks at locations 1, 2, and 4

(Figure 1) required repair. The only access to the joints was a manhole in 65 feet of water and nearly 4 miles offshore. ASI hired *Kruger B*, a 90-foot tugboat, as its work platform.

FIGURE 1: Locations of leaking joints in the deep ocean outfall. Number 4 was discovered during a preliminary repair inspection.

"The joint at location 2 was misaligned by 3 inches and beyond the tolerances of the repair sleeve," says Clarke. "The rough finish of the spun-concrete lining exacerbated the condition." Industry experts in Europe, Canada, and the United States agreed

The HD2 was loaded, piloted, and propelled through the pipe to the repair location from the surface (Figure 3). Using multiple cameras to ensure placement, a flexible Grouting Sleeve spot repair liner from Link-Pipe Inc. was locked in place by inflating the packer using the vehicle's water pump. Once the locking tabs engaged, the packer was deflated and the ROV removed.

The liners formed a seal against the leaking joints with spring pressure and elastomeric gaskets. During this repair, the site was abandoned for Hurricanes Frances, Ivan, and Jeanne.

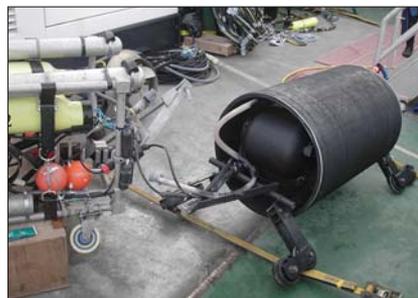
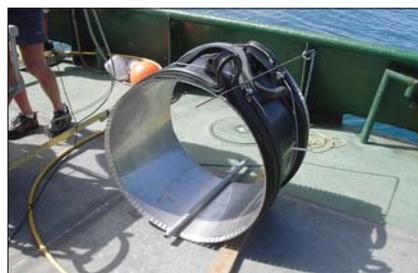
FIGURE 2: The ROV with modified packer from Logiball (upper) and a grouting sleeve from Link-Pipe (lower).

added a water pump with remote valving, and a digital stills video camera," ASI also modified the mainline packer from Logiball by adding floatation devices (Figure 2).

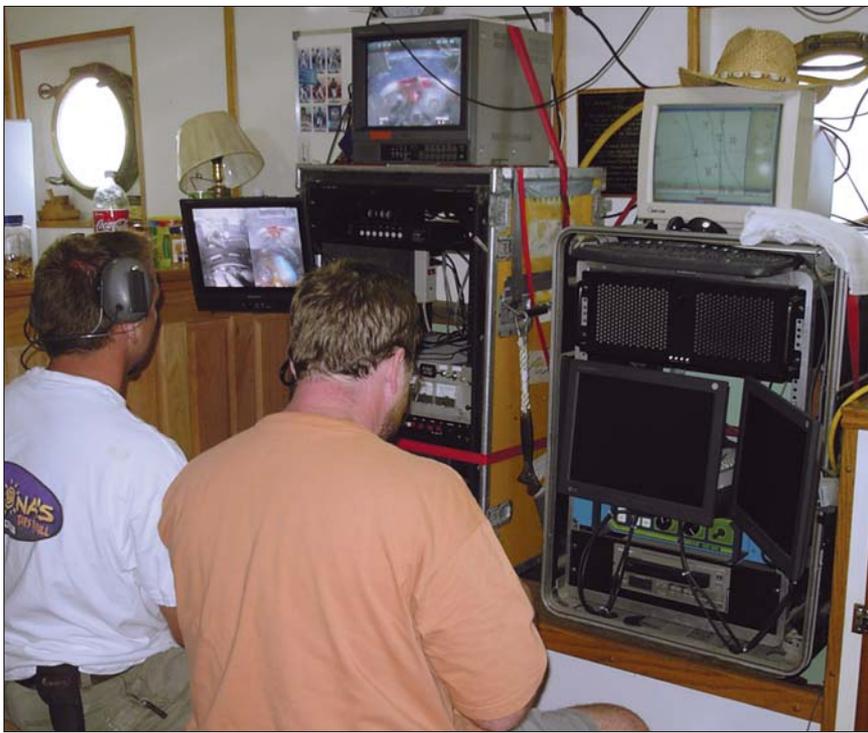
FIGURE 3: The ROV pilot (left) at the control consoles inside the tugboat uses three monitors. The one to his left is a multiple display, three for the ROV cameras and to display the positioning system for the boat. It shows the boat's location on a navigation chart and includes anchor positions. The middle monitor is the primary camera display and the one on top of the console is the permanent navigation display.

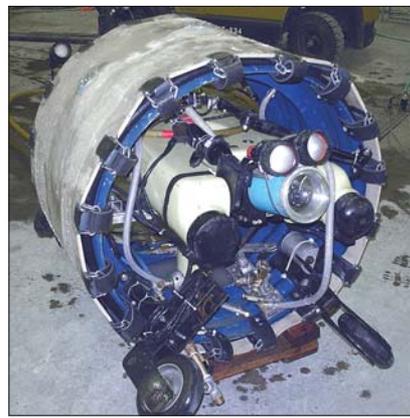
ASI then modified HD2 again (Figure 4) to include:

- More cameras and lights to help position the packer and monitor process.
- A pressure gauge to confirm inflation pressure at the packer.
- A return hose and valve to flush grout from the delivery hose during setup.

FIGURE 4: HD2, the delivery system, with the modified Logiball packer as an external frame.

The team adjusted the camera system and added tell-tales to the packer at the injection ports. (Tell-tales are flexible plastic strips that ride against the crown of the pipe, but pop up once into the gap.) This time the grout went straight into the leaking joint and produced a perfect repair.
