TROUBLE IN PARADISE

A deep-sea vehicle helps a contractor stop effluent leaking from a treatment plant's outfall into the Caribbean Sea

Repair pipe joints leaking effluent 400 feet below the Caribbean Sea

Ponce Wastewater Treatment Plant, Ponce, Puerto Rico.

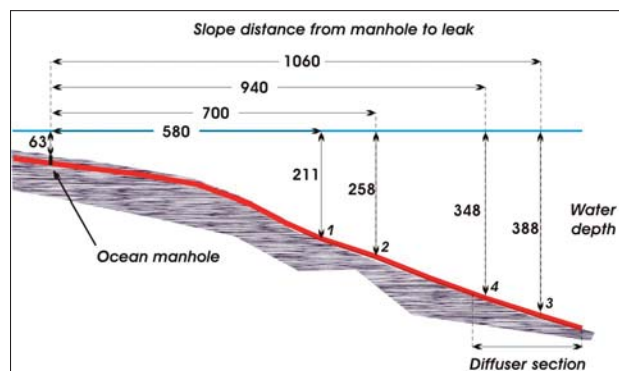
The concrete and weight-coated, spun-concrete-lined steel pipe lies in a backfilled trench. Running down a 20-degree slope near the offshore end, it breaks through the ocean floor and rests on specially designed cradles. Concrete mats provide additional ballast. Leaks at locations 1, 2, and 4

FIGURE 1: Locations of leaking joints in the deep ocean outfall. Number 4 was discovered during a preliminary repair inspection.

"The joint at location 2 was misaligned by 3 inches and beyond the tolerances of the repair sleeve," says Clarke. "The rough finish of the spun-concrete lining exacerbated the condition." Industry experts in Europe, Canada, and the United States agreed

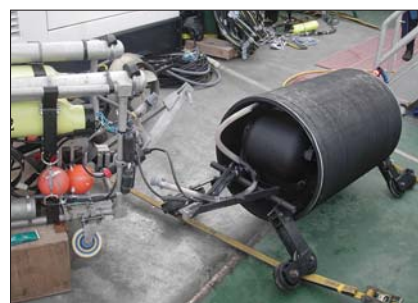
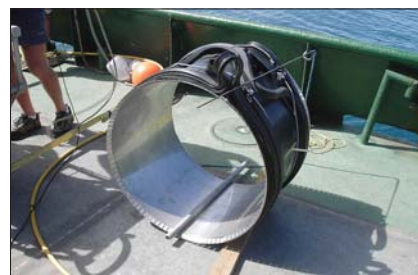
FIGURE 2: The ROV with modified packer from Logiball (upper) and a grouting sleeve from Link-Pipe (lower).

added a water pump with remote valving, and a digital stills video camera," ASI also modified the mainline packer from Logiball by adding floatation devices (Figure 2).

The HD2 was loaded, piloted, and propelled through the pipe to the repair location from the surface (Figure 3). Using multiple cameras to ensure placement, a flexible Grouting Sleeve spot repair liner from Link-Pipe Inc. was locked in place by inflating the packer using the vehicle's water pump. Once the locking tabs engaged, the packer was deflated and the ROV removed.

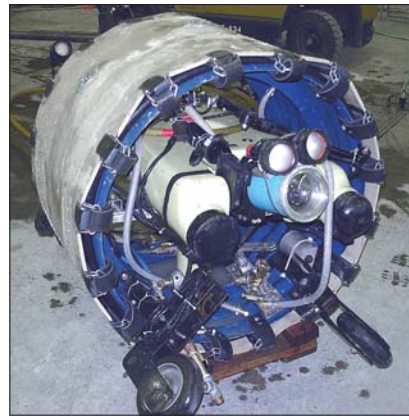
FIGURE 4: HD2, the delivery system, with the modified Logiball packer as an external frame.

ASI then modified HD2 again (Figure 4) to include:

- More cameras and lights to help position the packer and monitor process.
- A pressure gauge to confirm inflation pressure at the packer.
- A return hose and valve to flush grout from the delivery hose during setup.
