Video Pipe Grouting Eliminates Sewer Problems

Video Pipe Grouting, Inc., Newfield, New Jersey, recently did an infiltration/inflow study and infiltration reduction program for Freehold Sewer Company, Freehold, N.J.

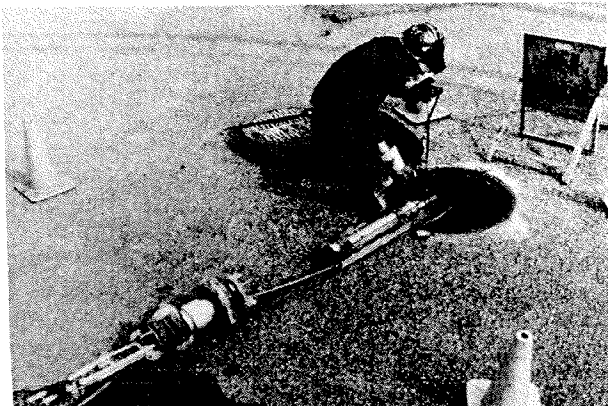
Dropped through manholes into successive sewer line sections, rehabilitation was done by a grout injector packer, left, guided by a closed-circuit TV inspection camera, right.

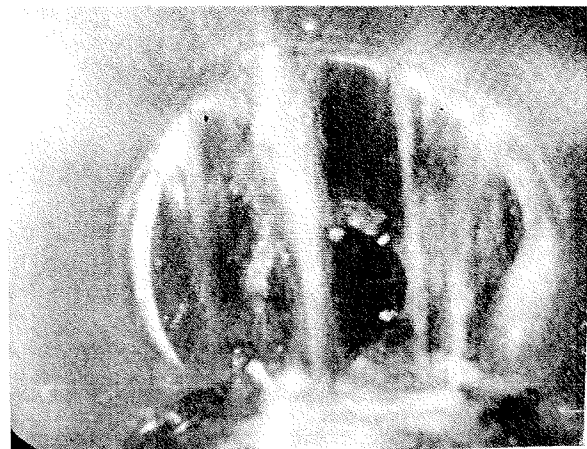
A typical leaking pipeline joint, as photographed from the TV screen.

Once in the line, the equipment was positioned by the cable. Actions were controlled by one of the technicians working inside a TV-grouting van. As TV pinpointed each joint, the grouter was cabled to the spot and positioned so its rubbers straddled the connection. Again by remote control, the diaphragms were air-inflated. Only about 10 percent of all joints met test-loss specifications. The rest failed and required treatment.

Grouting was accomplished with the packer still in place, pump pressure forcing the sealing materials into the annular space between the inflated packer diaphragms and out through the openings in the joint into the surrounding soil.

The process was continued for as long as the soil continued to accept the material. Most joints took 2 to 3 gallons. Some places required more depending upon void conditions outside the pipe.

After each grouting, air testing was again applied. Continuous pressure indicated the joint was now successfully sealed and the camera and packers were cabled to the next joint. In the few cases where pressures dropped, grouting was repeated and the test run again until specified air pressures were maintained.
