# Reaching Out

An innovative mix of technologies helps a Massachusetts sewer department seal leaking laterals, reduce I&I, and preserve treatment plant capacity

**Seal 34 laterals 20 feet from the mainline**

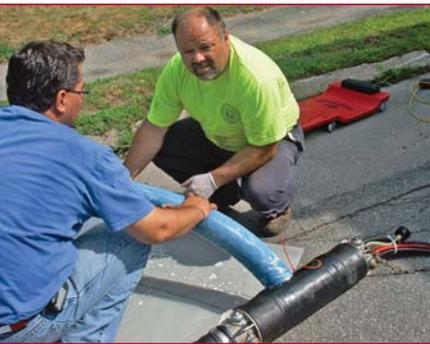
Grout truck operator Gary Millington (in fluorescent safety shirt) helps Marc Ancil of Logiball lubricate the inflated bladder with silicone. After lubrication, vacuum will retract the bladder into the hose carrier.

The lateral packer from Logiball has a 25-foot-long rubber hose, or carrier train, attached to the bladder launcher with pan-and-tilt camera. After the bladder is lubricated with silicone, vacuum retracts it though

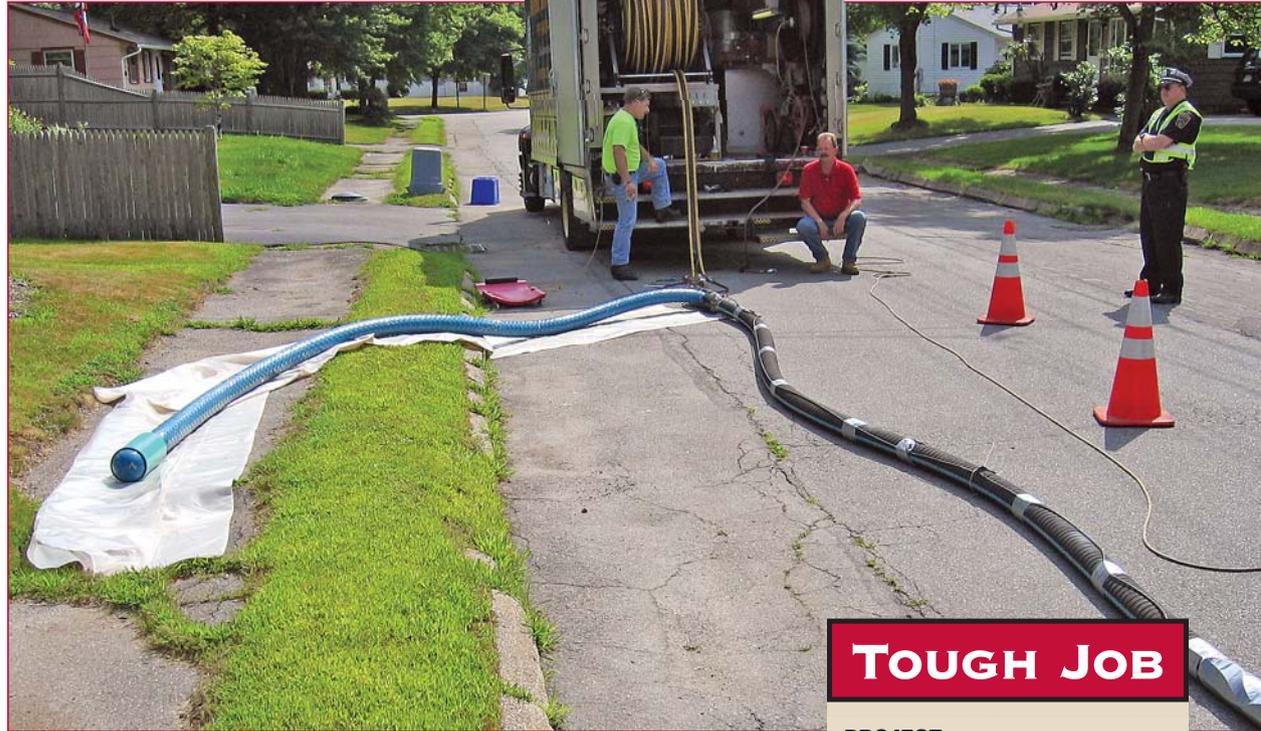
The inflated blue bladder is lubricated and ready for retraction by vacuum back into the hose carrier.

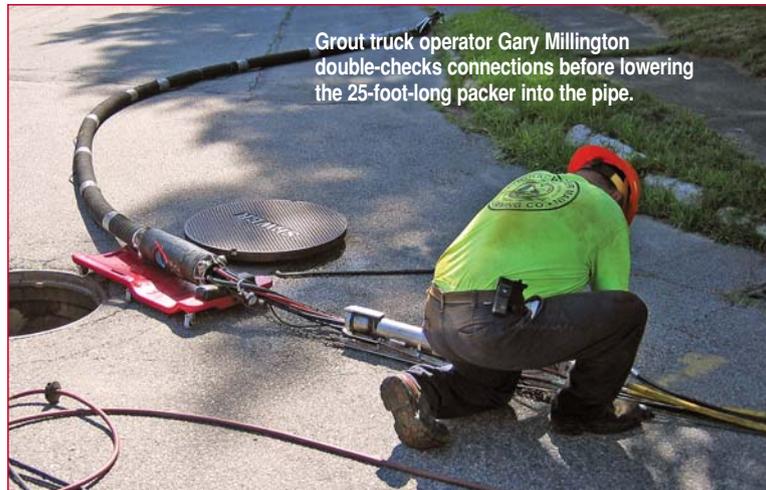
Grout truck operator Gary Millington double-checks connections before lowering the 25-foot-long packer into the pipe.

Millington had to learn how to get the carrier train into the mainline, position it, and inflate the bladder up the lateral. A maximum pressure of 40 psi seals the ends of the packer against the walls. "To achieve an effective seal of 20 feet, the packer travels 25 feet due to the plug at the end," says Falconieri.
