## FOCUS: SEWER

# DRIVING DOWN I/I

CIPP lining and grouting of lateral connections proves to be a sound formula for tightening sewers in Graettinger, Iowa

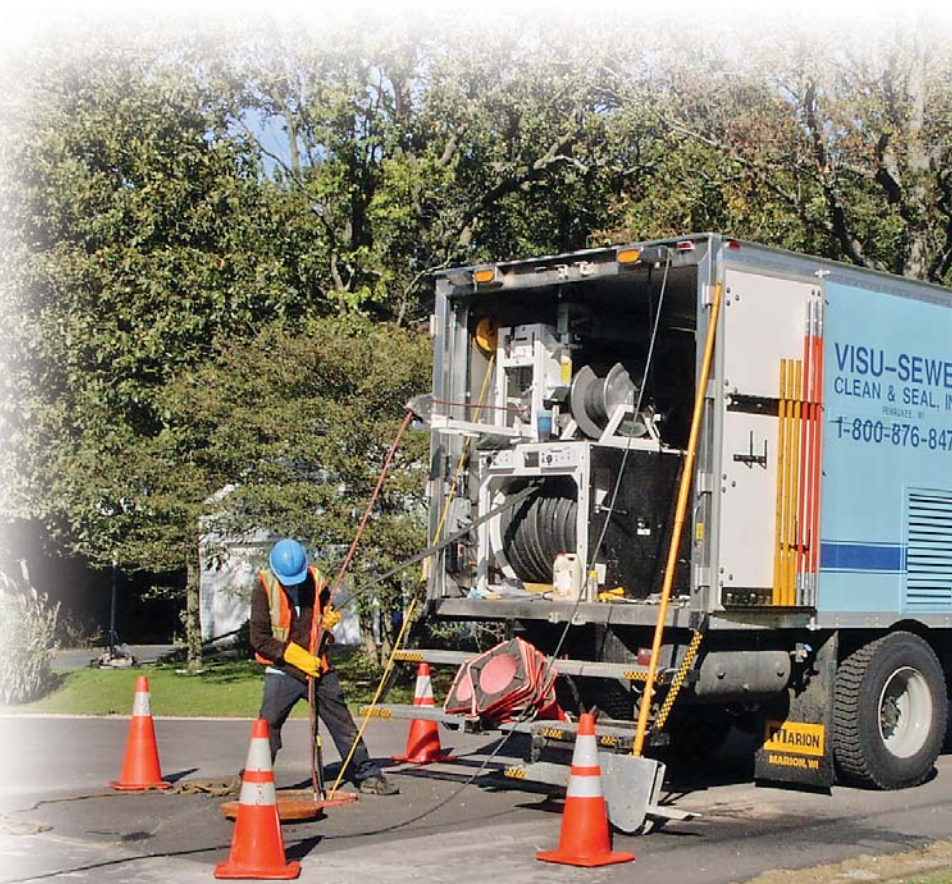
A technician from Visu-Sewer Clean & Seal Inc. starts an inspection of a sewer main in the City of Graettinger, Iowa, as part of the city's program to control inflow and infiltration.

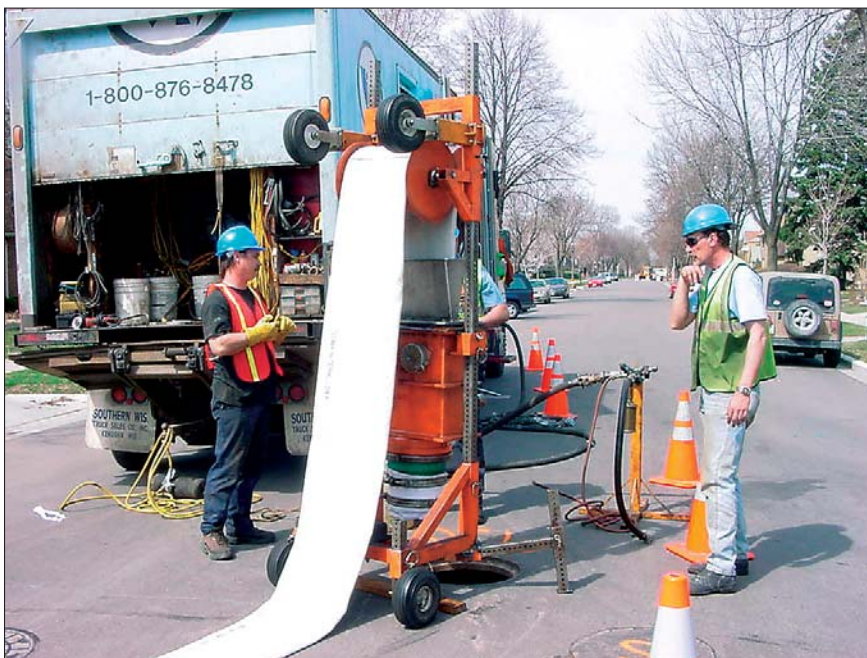
**A crew prepares a CIPP lining from National Liner for a trenchless repair job on a main in Graettinger.**

The custom-designed liner was made of 6 mm and 7.5 mm needle-woven polyester felt. The first step is a wet-out process in which the liner is laid on a processing table and a resin and catalyst system injected. The liner is then fed through rollers that compress the “dry bag” to a specified thickness and saturate it with resin.

To prepare the liner for the pipe, the first five to six feet are opened to a circular shape, and the leading edge is fastened to a circular frame. This results in a pocket into which water is pumped. The force of the water propels the liner down the pipe and turns it inside out.

Once deployed, the ends of the liner are secured, and the water is heated to 180 degrees F to activate curing. Temperature and water pressure are maintained throughout the process. Once cured, the liner is cooled and the ends trimmed and secured inside the manhole.

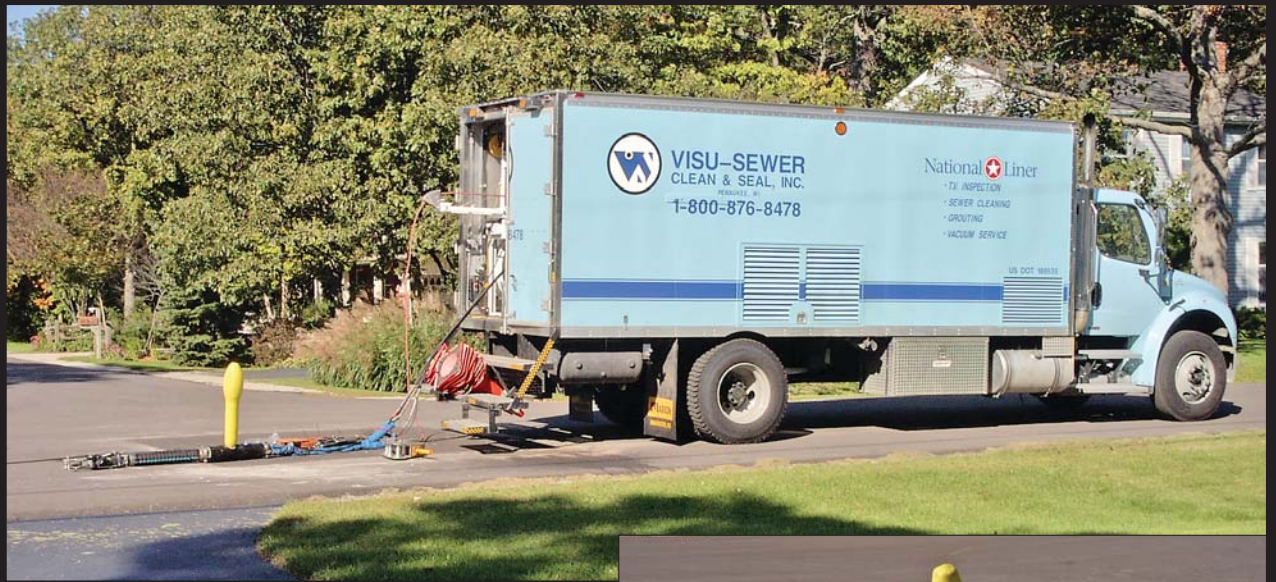
**A lateral packer system from Logiball Inc. is deployed on a grouting project. Grouting and CIPP lining were the city's preferred methods of sealing lines against I/I.**

In the last step to prevent infiltration, connections to the main line were grouted in place. During this process, three bladders within the lateral packer from Logiball Inc. were used to isolate the connection: two in the mainline (one on each side of the connection) and a third in the lateral. The bladders were inflated and the joint pressurized

to force gel grout out and around the connection. As the grout set, it stabilized the soil and formed a watertight seal.
