## Paper F-5-05

# Ways of Reducing I&I During Hard Economic Times

<sup>2</sup> Township of Falls Authority, Fairless Hills, PA

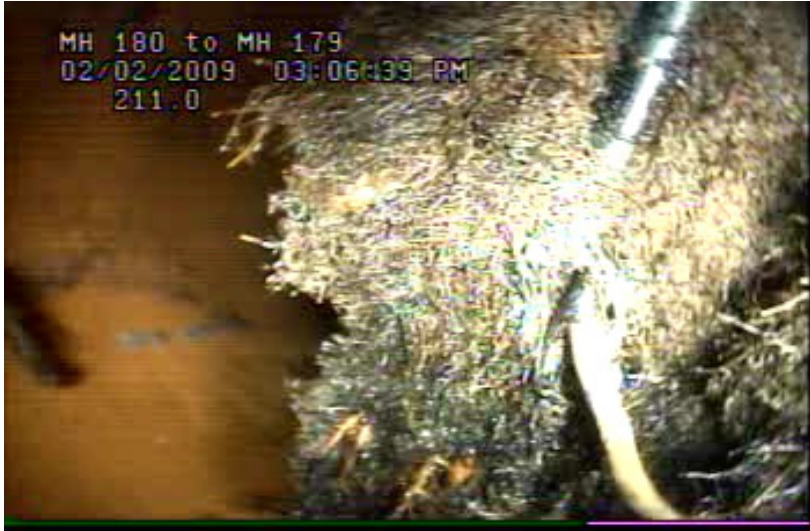
Figure 1 Root Ball in Pipe Segment MH 180 – MH 298  
(Courtesy of the Township of Falls Authority)

The cleaning and inspection portion of the contract showed evidence of root intrusion (Figure 1), multiple fractures (Figure 2), misaligned or open joints (Figure 3), protruding laterals, and infiltration at manholes. The inspection also showed that certain sections of pipe were in danger of collapsing and required replacement (Figure 4). The scope of work was expanded to include point repairs using 3-foot CIPP lining and manhole rehabilitation. The contractor also encountered tuberculated cast iron pipe during the project that required heavy mechanical cleaning.

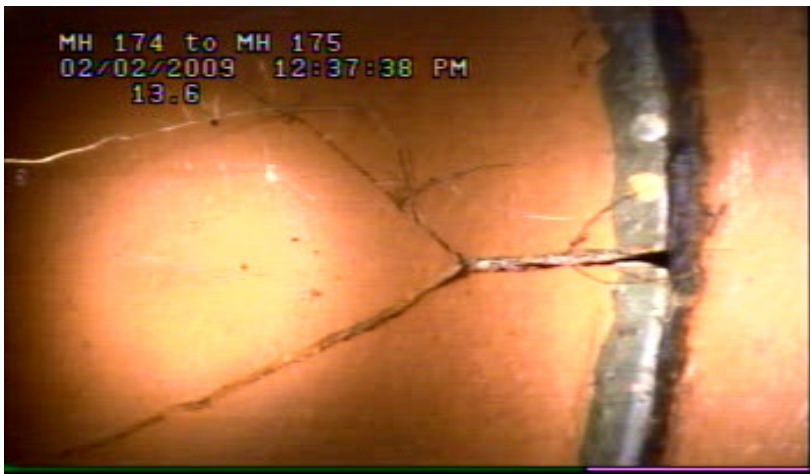
Figure 2 – Multiple Fracture in Pipe Segment MH174 to MH175  
(Courtesy of Township of Falls Authority)

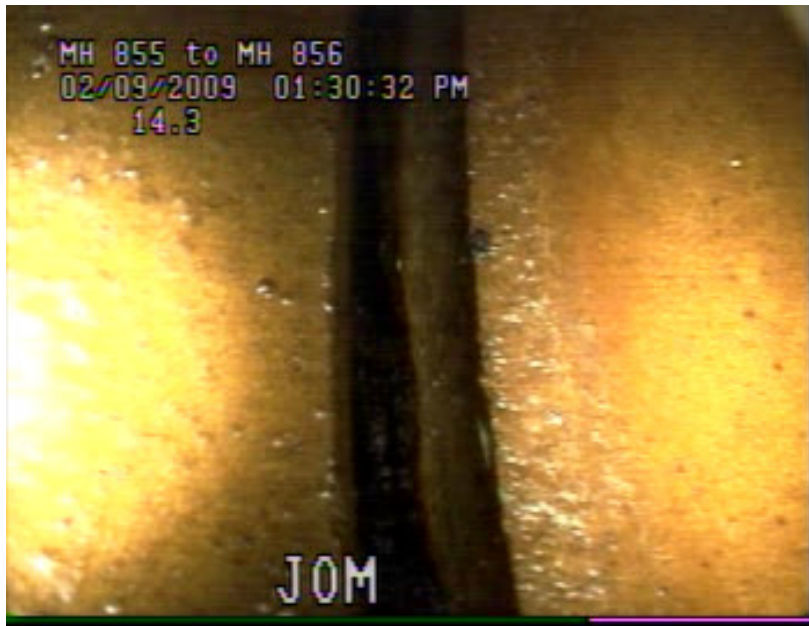
Figure 3 – Open Joint / Joint Offset  
(Courtesy of Township of Falls Authority)

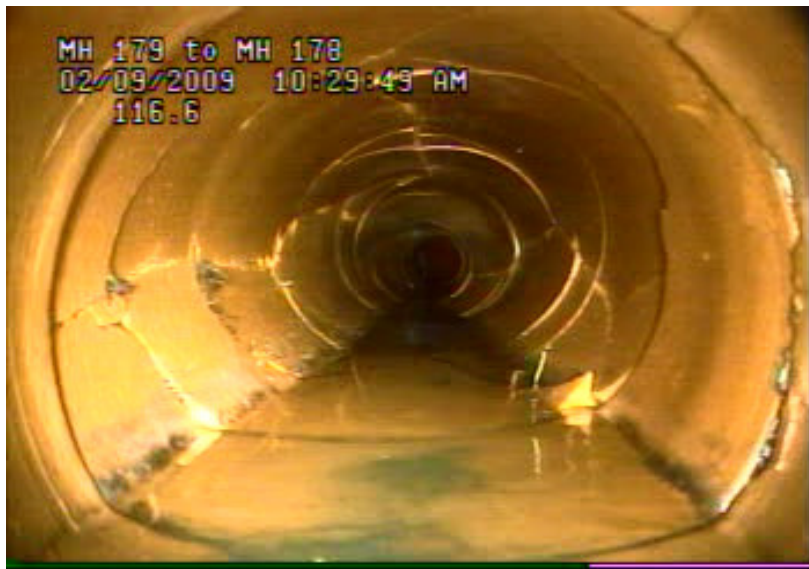
Figure 4 – Broken Pipe  
(Courtesy of Township of Falls Authority)

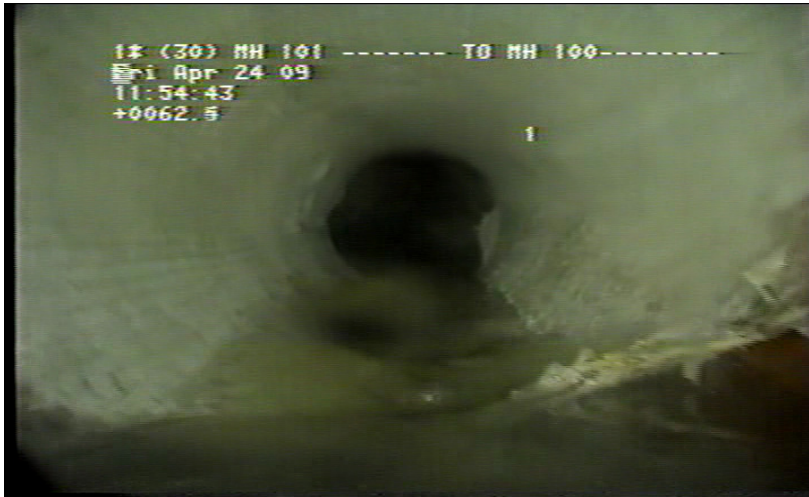
Figure 5 – CIPP Liner Point Repair, 3-foot length  
(Courtesy of Township of Falls Authority)

- 961 8-inch joints were grouted
- 76 10-inch joints were grouted
- 158 12-inch joints were grouted
- 10 lateral protrusions were cut
- 1 pipe relining
- 8 Short CIPP repairs (3-foot lengths)
- 7 CIPP repairs (over 3-feet in length)
- 1 Saddle Liner
