Framingham, MA

Project: Wickford Road Siphon, located under the Sudbury River, Framingham, MA

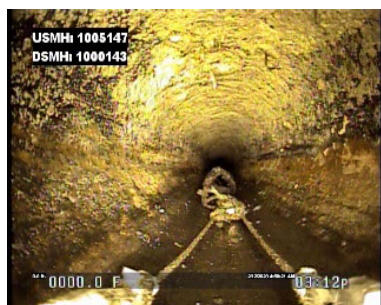
Photo of siphon just outside of
The start of the siphon structure
Here the camera is traveling
Down the incline of the siphon

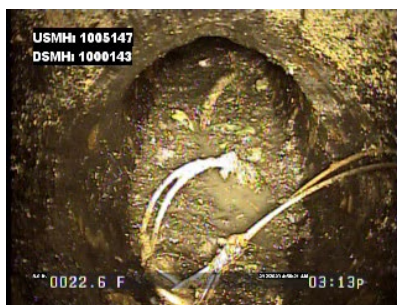
This is right where the siphon
starts its horizontal run

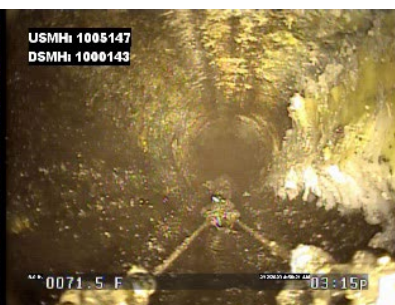
Barrel of the siphon, horizontal
run, note heavy grease present

Before any long-term solution could be implemented the siphon needed to be cleaned. Cleaning siphons can be a difficult task. The debris in the pipe typically is exceedingly difficult to remove since it needs to move uphill to the downstream end of the siphon. There was also moderate to heavy grease lining the siphon in certain areas that needed to be removed as well.

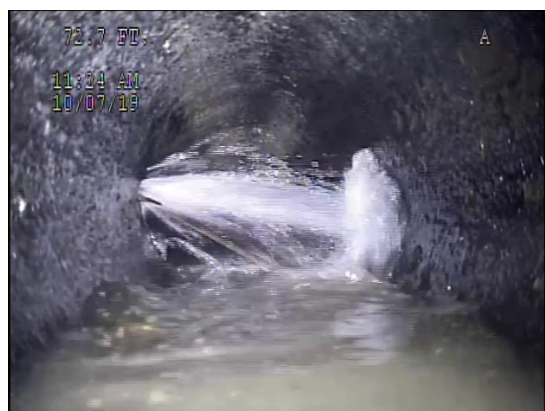
The City of Framingham's initial goal was to clean and televise the siphon. Upon completion of the television inspection it was discovered that there was a significant amount of infiltration entering into the siphon about 73 feet from one end of the siphon. The infiltration entering the siphon from this leak was at least 40 gpm. GMPS was called in to help under its annual on-call maintenance contract with the City of Framingham.

Once the siphon was cleaned the leak could be
readily seen coming in from the river above.

This certainly was not a minor leak. The structural integrity of the siphon would have been at risk if soil and fines continually washed in, undermining the siphon. This leak needed to be stopped, but how? With the configuration of the siphon, a traditional packer for grouting would never fit past the siphon elbows. GMPS presented the situation to Logiball, Inc. who designed a special packer just for this job. The packer had to be long enough to straddle the leak but flexible enough to negotiate the bends in the siphon. Logiball designed an 8-inch diameter packer with a 3-foot long grouting span, which would ensure the packer was placed over the leak.

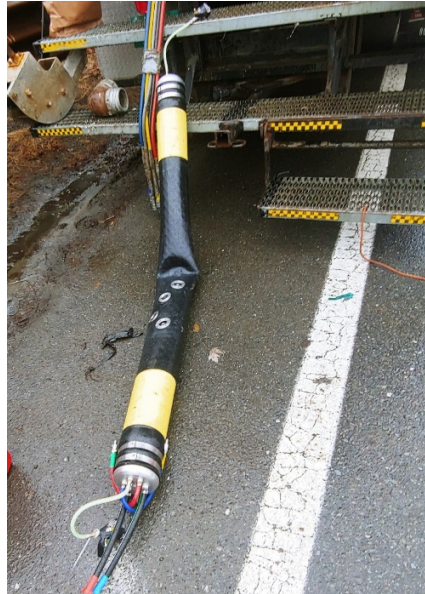
Special Logiball packer

Once the packer was delivered to GMPS the work was scheduled, but the challenges had only just begun. The grout used was American Chemical Grout Company's ACG-AG Acrylamide-MBA premix grout. This grout has an extensive history of successful use in the sewer collection system industry. It has the same viscosity of water and a gel time that can be adjusted, as needed. Typically, a 10 percent mix by weight is used, but due to the high volume of infiltration from the leak, a stronger 15 percent by weight mix was used. The gel time was 15 seconds long and GMPS pumped in three phases, injecting about 20 gallons per phase. The grout works by filling the void created by the packer sealing against the pipe walls. Once the void area is filled, pressure builds, and the grout penetrates the holes in the pipe from inside. Outside the pipe, the grout displaces the water in between the soil particles and forms a gel soil matrix that is impervious to water.

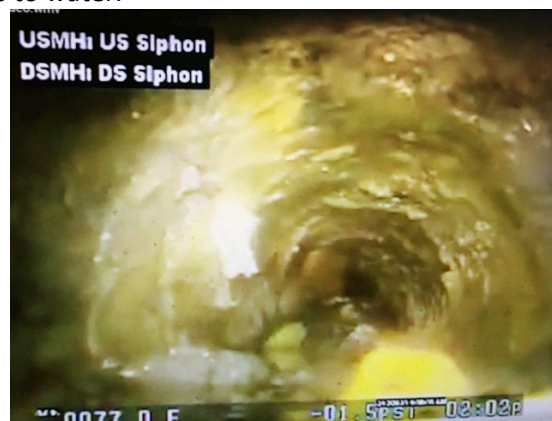
Leak successfully stopped. The excess grout inside of the siphon is excess grout from the filling of the void created between the packer and the pipe. This excess grout was removed.

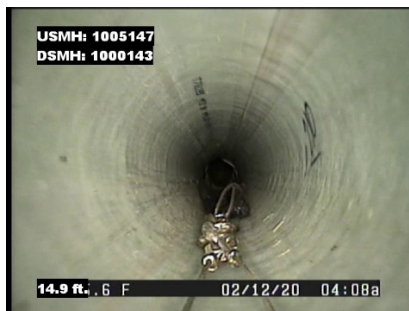
Photo dropping into siphon

Once the liner was on the jobsite, and the bypass line connected, the CIPP lining could begin. The liner was installed, and steam cured in approximately 8 hours. In the end, the liner came out as expected. There were a few minor wrinkles at the top by the siphon bends, but the remainder of the siphon came out perfectly.

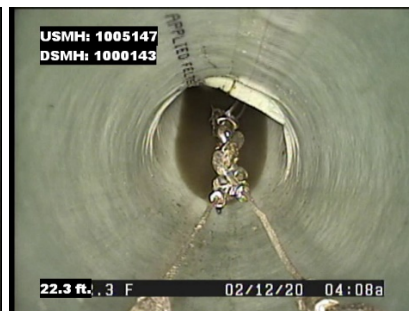
Photo at the bend
A few minor wrinkles at the
Top were expected

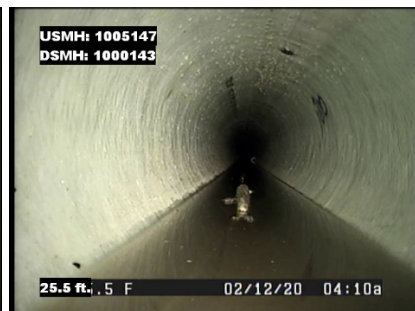
Photo in the main horizontal
main barrel section of the
siphon
