IKT Compare: Can Short Liners Repair House Connections?

Short liners are often the first choice for **repairing local damage** in house connections. But, can they deal with **seriously damaged pipes**? The results of the new **IKT-Compare project "Short Liner for House Connections"** are now available.

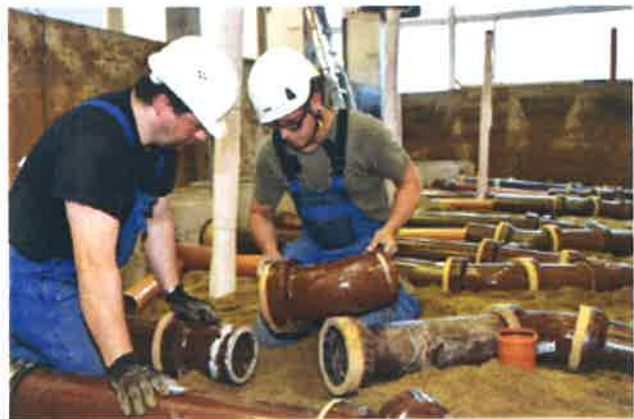
Deliberate defects: IKT has installed eight test sections with a total of 64 cases of damages in its large test pit.

For this project IKT built eight identical **1:1 scale rigs**, in its large-scale test pit (15m by 6m by 6m), into which

length of sewer to which were attached one **house connection pipe** on the same level as the sewer pipe and two house connection pipes from a higher level. The house connection pipes were prepared with **defined areas of damage**, including milled patterns of **cracks**, the removal of some or all of the **joint seals** and **broken sections**. A total of **64 damage patterns** were produced – eight in each of the eight test rig setups.

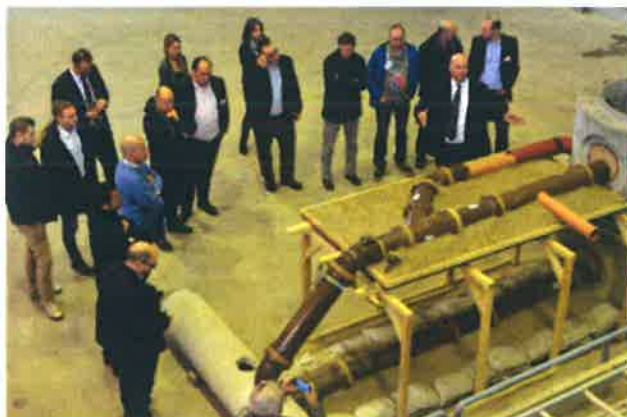
Two up, one down: the test set-up.

- **Test Setup I** (the lower house connection pipe, to which a 2m head of external groundwater was subsequently applied): cracks, a broken joint, a radially displaced joint and a joint displaced at an angle
- **Test Setup II** (the two higher house connection pipes, to which a 1m head of groundwater pressure was subsequently applied): a defective change of pipe material, defective change of pipe diameter and material from cast iron DN 150 to PVC DN 125, a defective change of pipe diameter and material from clay pipe DN 150 to PVC DN 125, and a break in the joint of a 45 degree bend

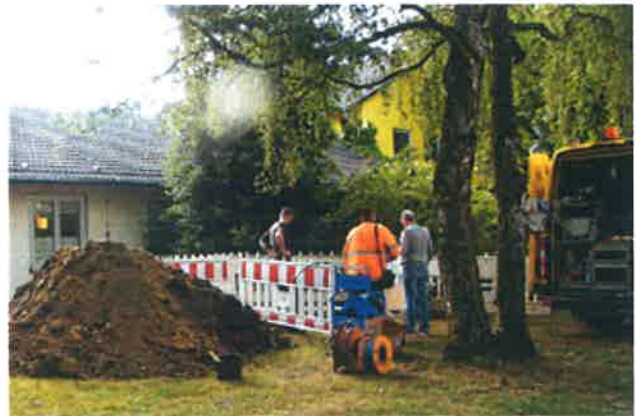
In-situ tests: lab tests were validated through in-situ observation of the same systems being installed at actual construction sites.

In addition to physical tests, the **QA/QC procedures** were examined. The laboratory results were validated through **in-situ observation** of the same systems being installed at actual construction sites. The **final scores** in this IKT Compare test are based on these three evaluations. The **range of grades** applied is from VERY GOOD (score of 1.0) to INSUFFICIENT (score of 6.0).

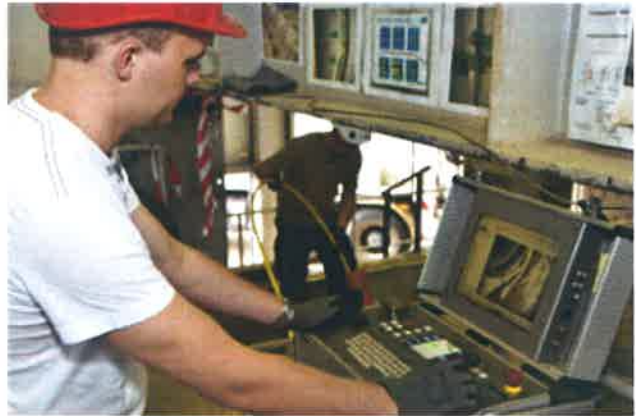
Ongoing observation. IKT testers regularly check the installed short liners for leaks.

Frequent visual inspections and leak tests were undertaken as the programme progressed. Finally, when the test rigs were exhumed from the test-pit, the **cross-section reduction** was measured and the **adhesive tensile strength** and **ring stiffness** of the installed liners were assessed.

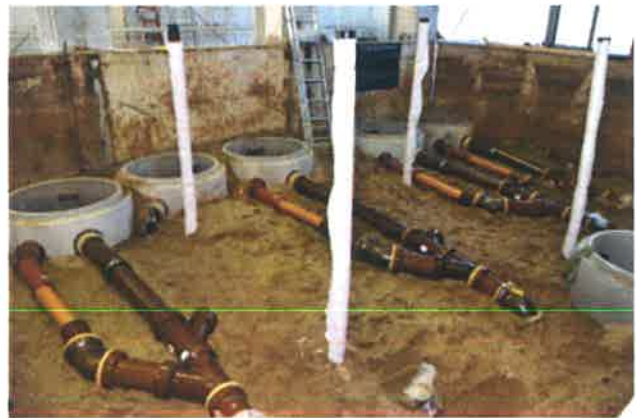
Repair objective: to seal damaged house connections.

In this IKT Compare project, the system suppliers demonstrated that **serious damage** to house connections can be **reliably sealed** using short liners, including breaks, cracks, misalignments and deflections. In particular, the **Twinbond** and **Trelleborg** systems proved to be the **most reliable** under permanent groundwater load, jetting, simulated backflow events and changing groundwater levels. For this they were deservedly awarded the **score of 1.0** for water tightness.

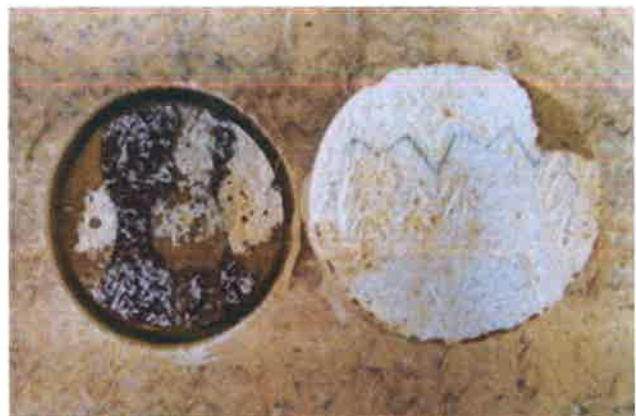
Adhesion test

The structural stability testing of the short liners showed that they basically have **reliable adhesive and load-bearing performance**. For products with full-surface bonding of the liner to the host pipe, hardly any abnormalities were observed. i.e. no crack formation. no excessive deformation.

no stability failure nor large-surface loosening of the adhesive bond. Five systems showed **partial loosening** of the adhesive bond at points of changing diameter or pipe material, albeit without any consequences.

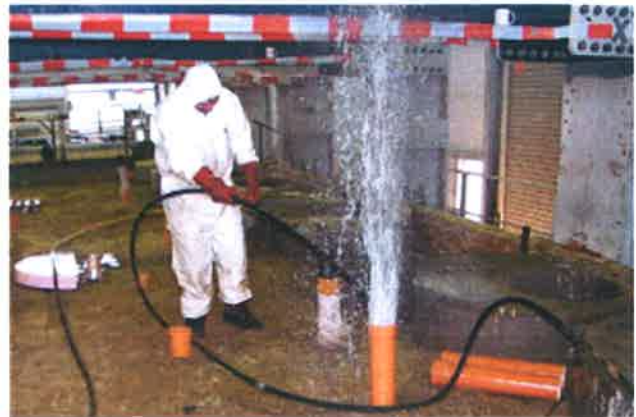
High-pressure jetting did not affect the short liners.

The test scenarios **simulating sewer operation**, such as high-pressure jetting, water backing-up in the pipe, and changing groundwater levels, had **no significant effects** on system performances.

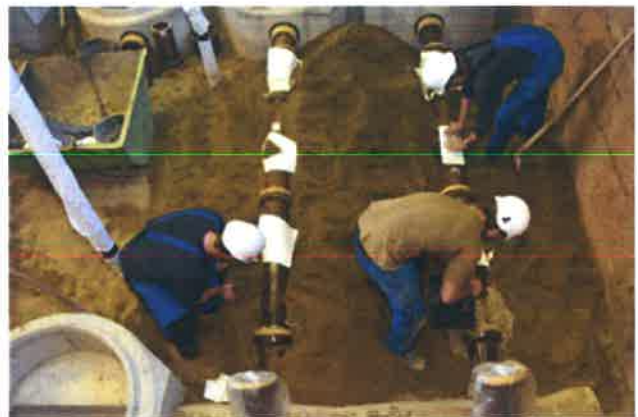
Defined damages: preparing the test rigs
