Video Pipe Grouting Eliminates Sewer Problems

Video Pipe Grouting, Inc., Newfield, New Jersey, recently did an infiltration/inflow study and infiltration reduction program for Freehold Sewer Company, Freehold, N.J.

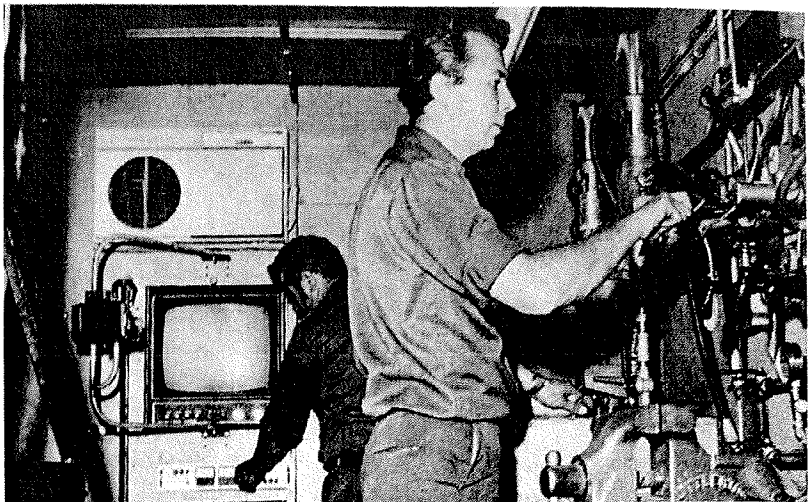
Within the truck a technician (left) controlled and monitored both underground camera and grouting machinery while a second technician (right) remotely selected, formulated and placed the chemical/catalyst grout sealant itself.

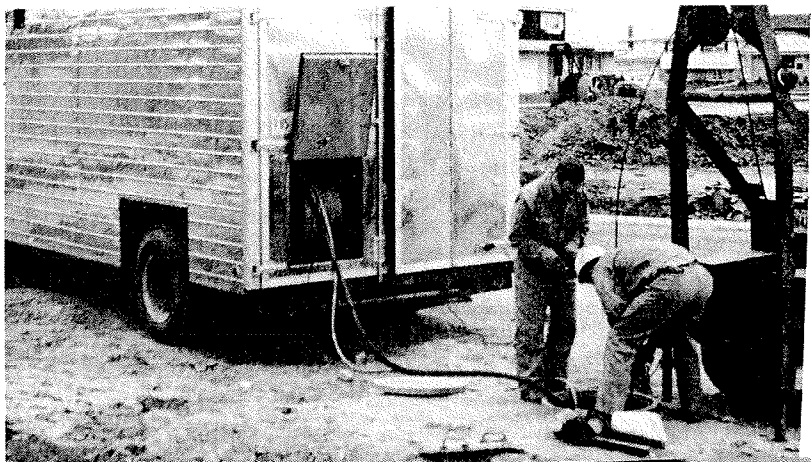
Video Pipe Grouting's self-contained television/laboratory/grouting control truck brought both inspection and repair functions direct to the work site.
