# Experience Counts with Unique Grouting Project

by Allen Thomas

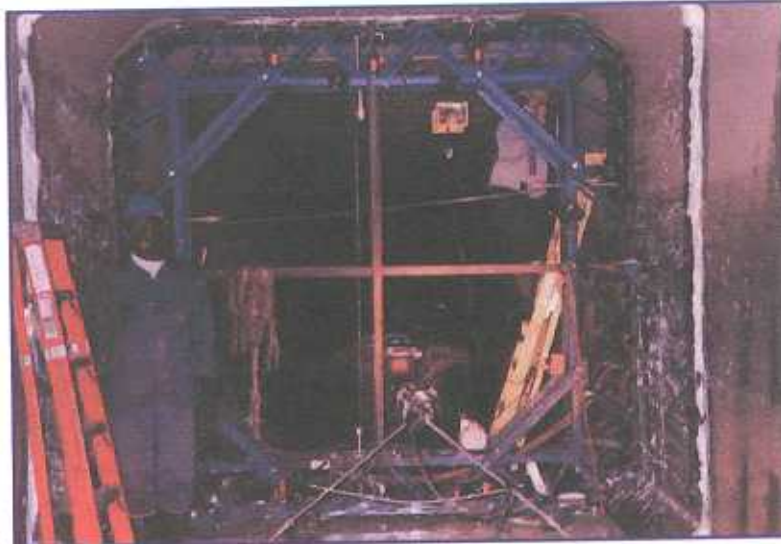
A custom-designed packer grouts and seals the culvert joints.

The unusual shape of the box culvert required a specially designed packer which was provided by American Logiball. The packer consisted of a steel frame on rollers and an inflation bladder designed to adapt to the square culvert and the haunched (mitered) corners.

"Logiball did a nice job building the packer for us," Sirna said. "We pumped acrylamide grout which we prefer. The packer design allowed us to inject the grout under high pressure, so we were assured of filling all of the voids outside of the joints."

Sirna said, "We pumped under high pressure — 20 psi. When we could read the back pressure or see the grout entering at the next joint, we knew we had sealed that area."

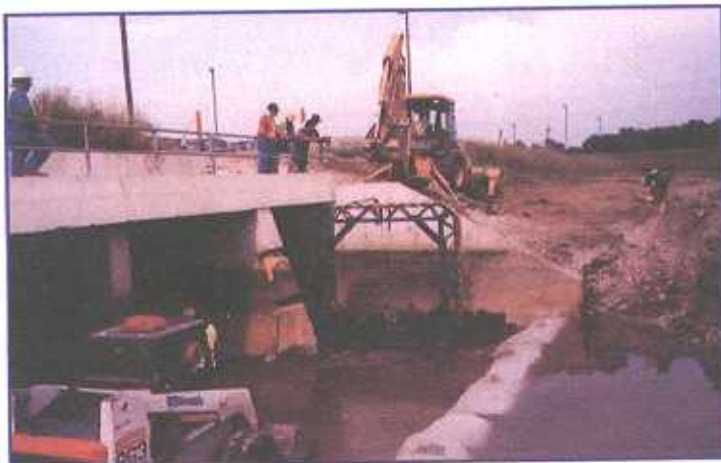
**W**hen Norm Sirna with Specialty Sewer Services Inc., Hazelwood, Mo., heard about the problems with a 10-ft square box culvert he knew it was going to be an unusual job. The joints on the 7-ft long sections had opened when the culvert settled, allowing water and sand to enter the box and cause further settlement.

"We were called in to seal the joints," Sirna said. "It was a situation where the culverts had been installed on open bedding stone which permits sand to move into the void space as the water table rises and falls. The weight of the sections is about 22,000 lb. We had to grout every joint to provide support and stop the running sand."

The packer awaits launch in the box culvert which was filling with sand from failed joints.

Preparation for the work required placing a skid-steer loader in the culvert to remove the sand and debris. This effort was then impacted with unseasonably high water conditions which caused silting in of the intake structure. Bypass

pumping was then required and one 8-in. Godwin pump running 24 hours per day was able to remove the extraneous water. Once most of the sand and water was removed, Specialty's crews applied quick-setting cement to the joints, leaving access holes to inject the grout through the sealing packer.
