FIRST IN THE WORLD

A unique approach to lateral grouting keeps homeowners contented with the public works department in a southeastern Wisconsin village

TOUGH JOB

Grout 30 to 35 feet of 6-inch clay laterals from the sewer main to the property line without using the cleanout access

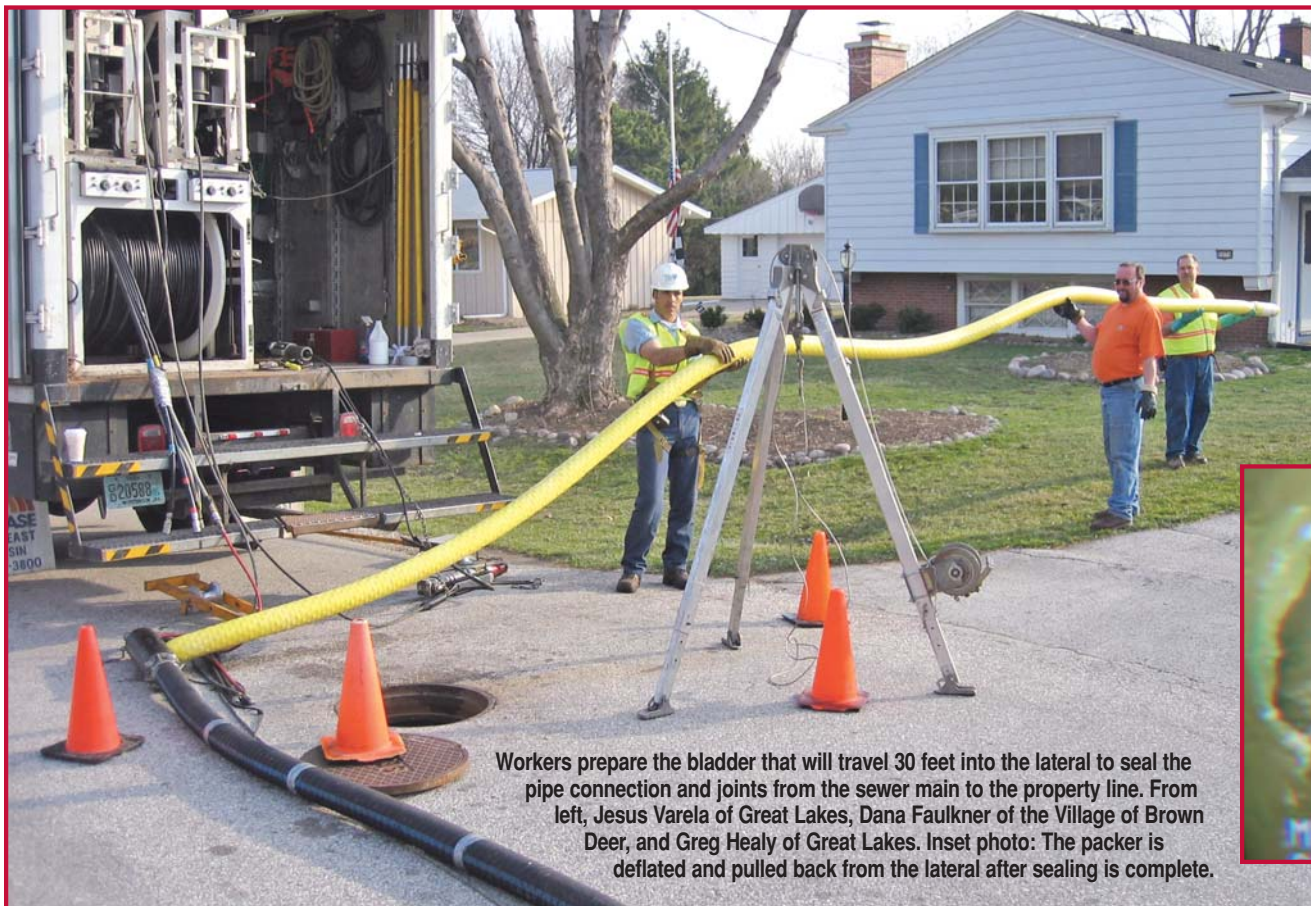
Workers prepare the bladder that will travel 30 feet into the lateral to seal the pipe connection and joints from the sewer main to the property line. From left, Jesus Varela of Great Lakes, Dana Faulkner of the Village of Brown Deer, and Greg Healy of Great Lakes. Inset photo: The packer is deflated and pulled back from the lateral after sealing is complete.

The packer with pan-and-tilt camera was winched through the mainline, then rotated to align the launching tube and grouting plug with the lateral. Air pressure (about 40 psi) sealed the ends of the packer against the sewer walls, expanded the tube to create a mixing chamber for the grout and catalyst, and inverted the plug into the lateral.

"We were standing 60-feet away at the manhole, but we could still hear the bladder moving up the laterals and the pop it made when fully inflated," says Ancil. Although the forward end of the bladder sealed against the wall of the lateral, its expansion was restricted, and that left an annular space.

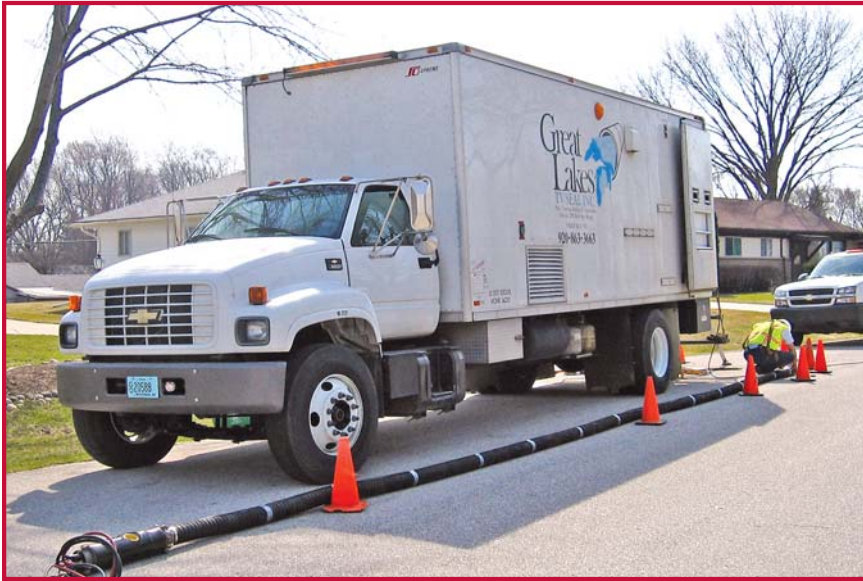
Jesus Varela of Great Lakes sets up the 45-foot-long lateral packer.

Logiball manufactured a 45-foot-long rubber lateral grouting plug (or bladder) and adapted it to the company's lateral packer, then made sure that it worked

with everything in the truck. According to Ancil, the hardest part was making sure the bladder inverted properly with air pressure and retracted into the mainline assembly with vacuum. "That's the part that had never been done in the world before," he says.
