Out of Round

A custom-built elliptical packer enables a New Jersey borough to keep its street reconstruction program on schedule

PROJECT:

Chemical grout defective joints in an elliptical pipe under a newly surfaced road

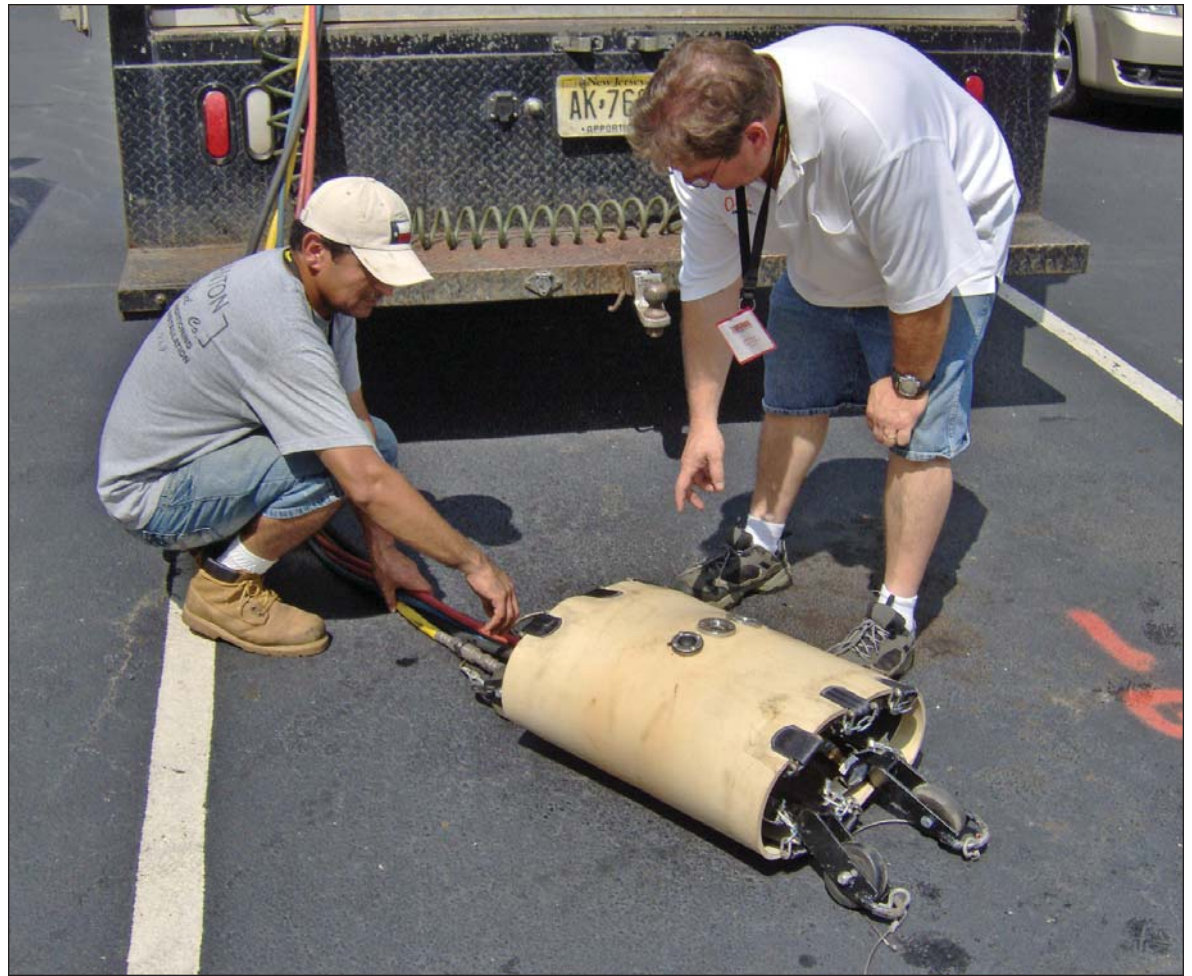
Antonio Rocha (left) from Oswald Enterprises Inc. in Belford, N.J., attaches hoses that deliver air and grout to the 14- by 23-inch elliptical packer custom-built by Logiball Inc. Project manager John Read oversees the process. (Photo courtesy of Oswald Enterprises Inc.)

Read's crew used a stand-alone electric winch to pull the elliptical packer downstream. Guided by the camera, Read set the packer at a joint and inflated the bladders to isolate it. Separate hoses then delivered the

two-part chemical grout to the packer, which raised the injection pressure to 10 psi, the equivalent of 23 feet of head.

Once injected, the grout filled the annular space around the packer, flowed out the defective joint into the soil, and gelled to form the seal. How much grout to inject depended on the porosity of the soil and voids behind the pipe.

"Because the pipe was eight feet deep, we needed only 5 psi," says Read. "However, we used 10 psi and left nothing to chance." It took two days to seal 23 joints, each averaging five gallons of grout. Then Read televised the pipe again. The repairs were perfect.
