Stemming the Tide

Island community takes an innovative approach to tightening its collections system and reducing treatment volume

Grouting and lining 38,000 feet of pipe to reduce I&I in one of the community's most problematic basins

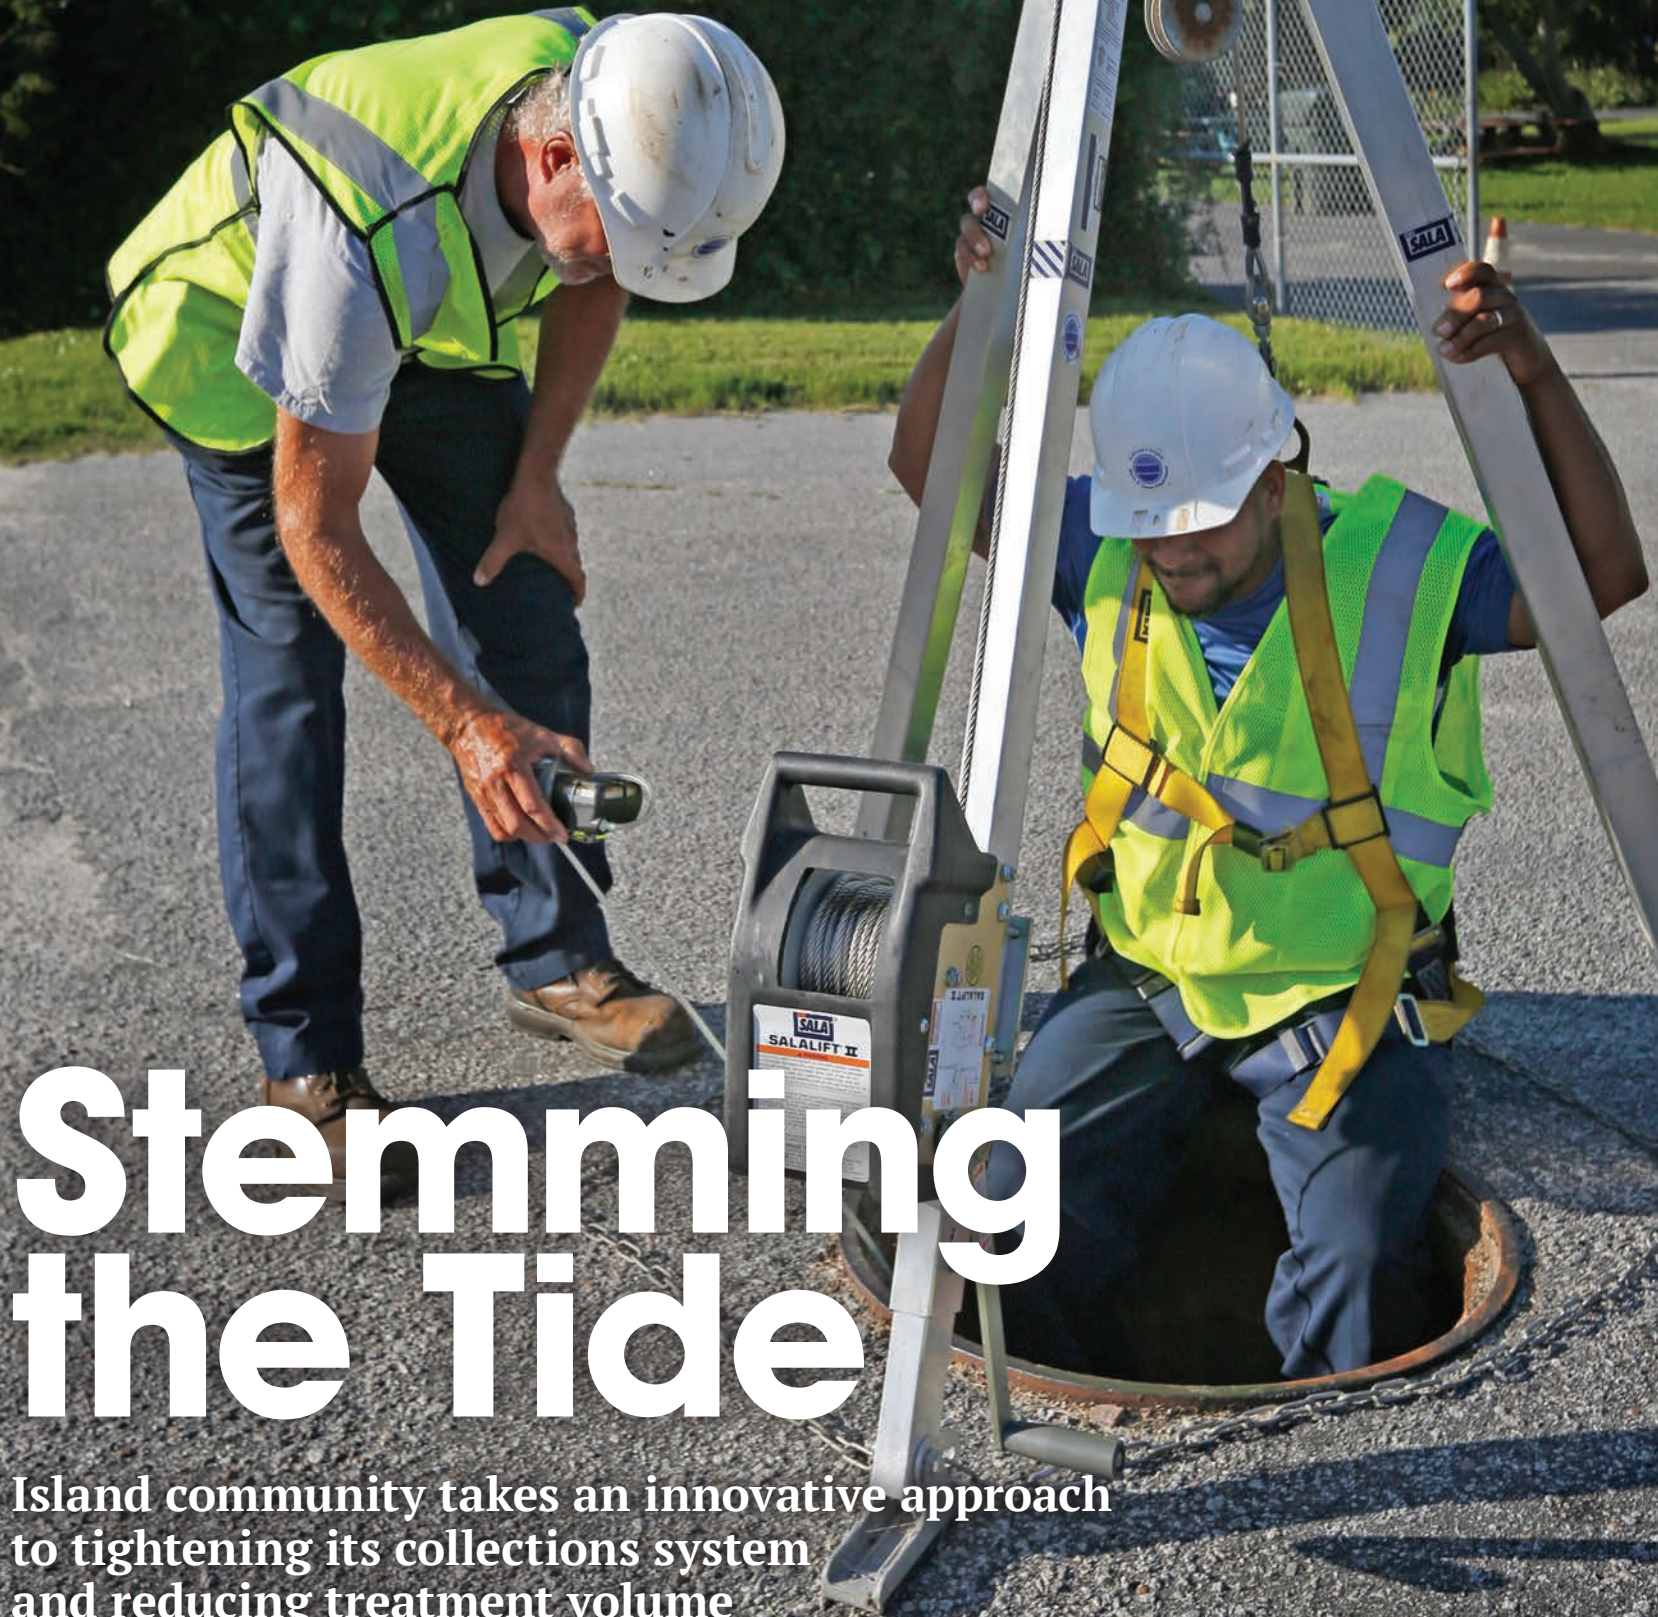
OPPOSITE PAGE: Sullivan's Island Water & Sewer Department operator John Myers checks a gas monitor while Chief Operator Darrell Noisette prepares to enter a manhole for a visual inspection. RIGHT: Work begins on Gull Street on the island.

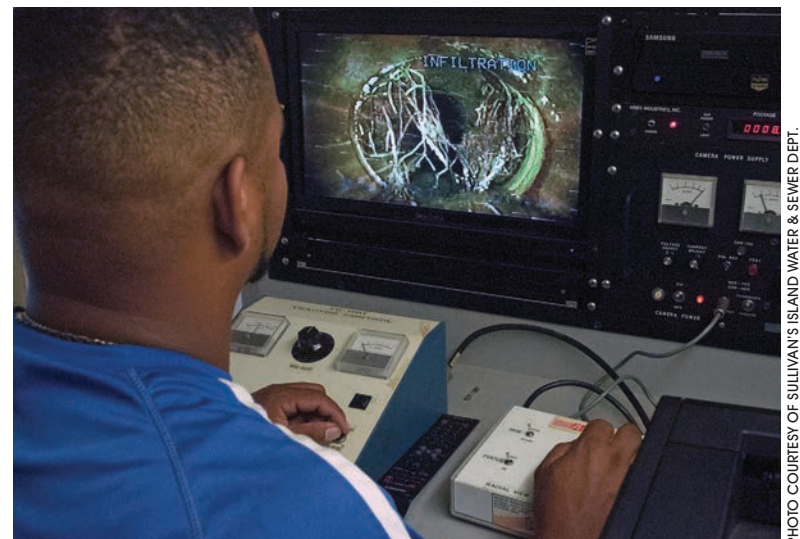
Darrell Noisette pauses to view an infiltration source while inspecting a sewer main on Sullivan's Island.

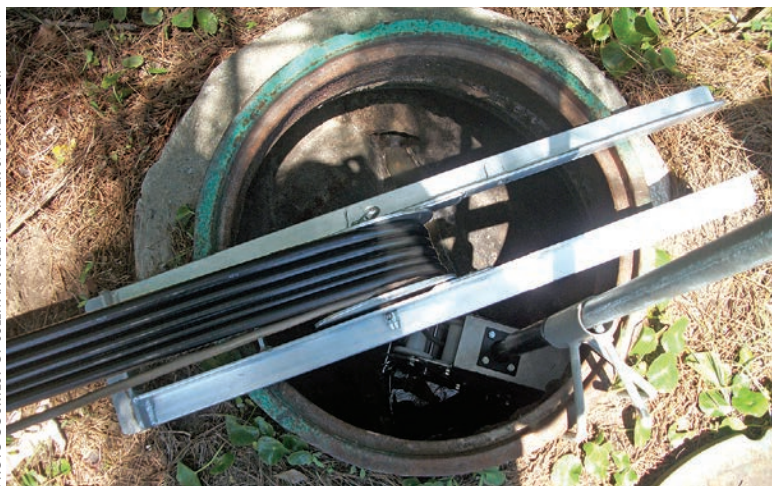
A camera cable, hoses carrying the two-part grout mix, and air lines for the grout packer pass over a roller on a manhole. The grout packer is attached in the sewer line.

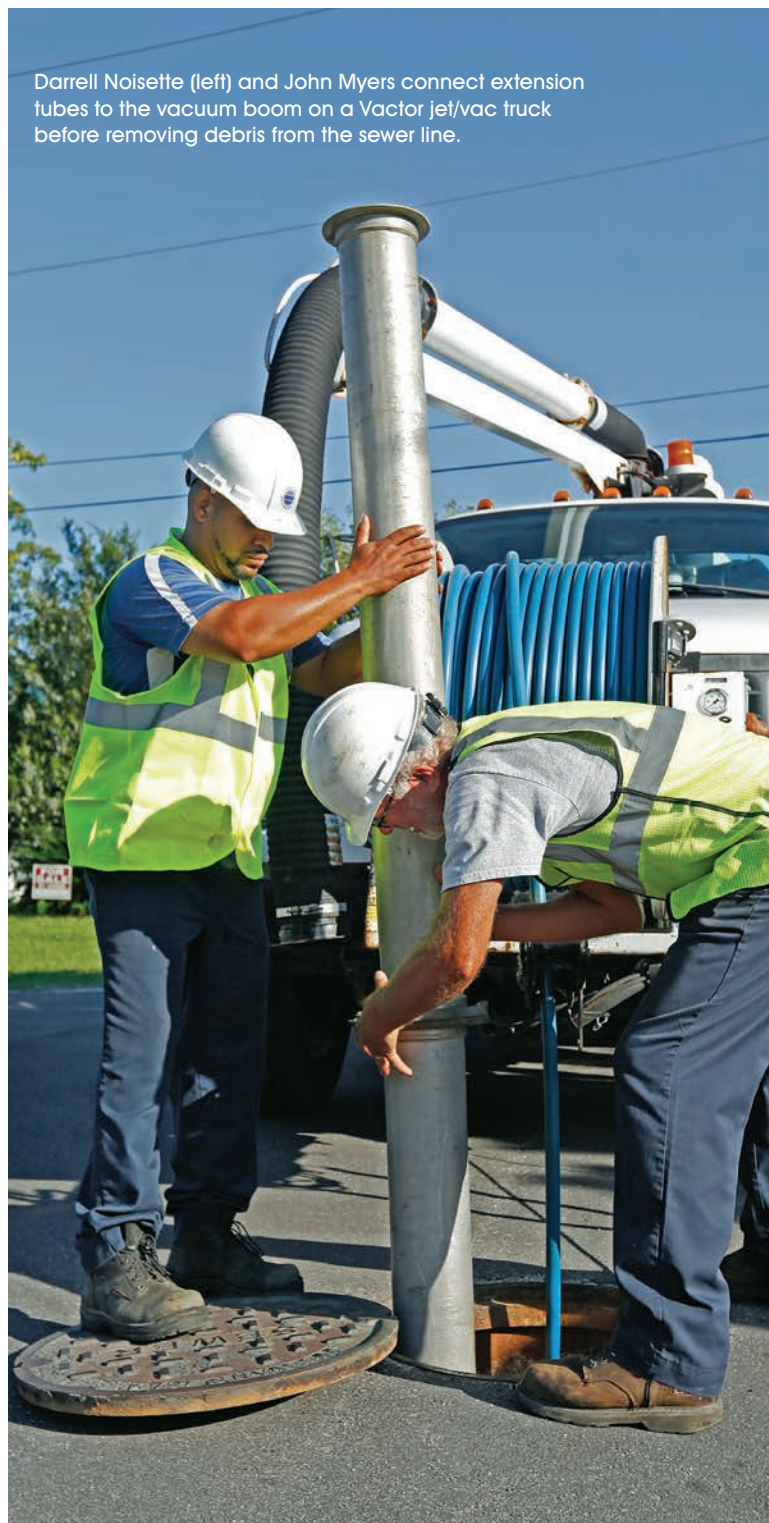
Darrell Noisette (left) and John Myers connect extension tubes to the vacuum boom on a Vactor jet/vac truck before removing debris from the sewer line.
